Detailed Unexploded Ordnance (UXO) Risk Assessment Report

Detailed Unexploded Ordnance (UXO) Risk Assessment

Project Name	Northfleet, Gravesend, Kent
Client	GVR Geoservices Ltd
Site Address	Northfleet, Gravesend, Kent, DA11 9AD
Report Reference	DA11104a-00
Date	19/05/23
Authored by	CJ
Revised by	HJ
Final Check	AT

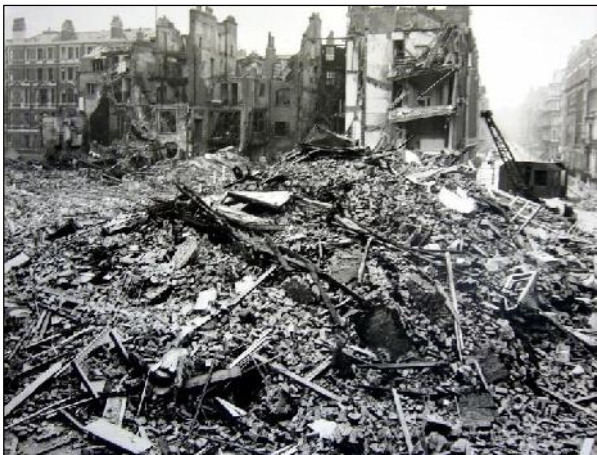
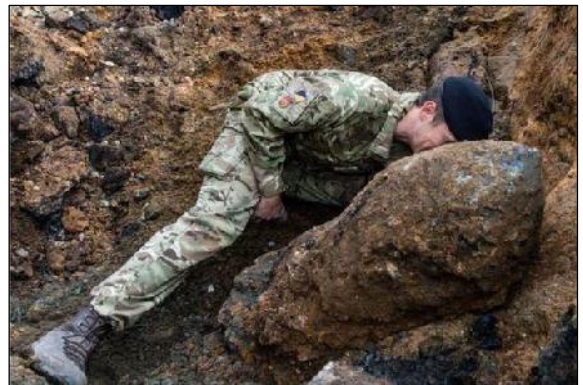
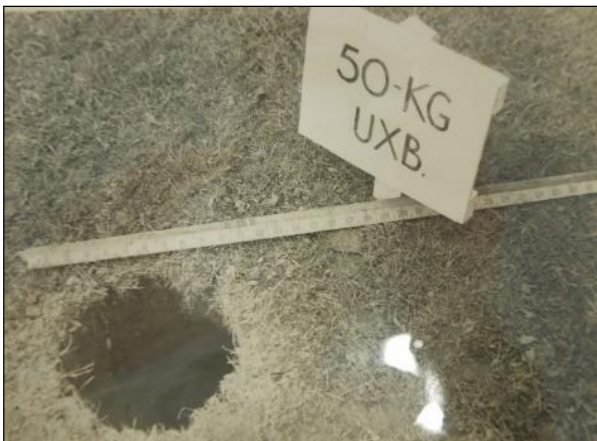
Top: J-curve Effect - Due to angle of entry, unexploded bombs would often end their trajectory at a lateral offset from point of entry, often ending up beneath adjacent extant structures/sites. The photograph above shows a 250kg unexploded bomb found in Bermondsey in 2015, pointing upwards, demonstrating 'J-curve'.

One of the most common scenarios for UXO going unnoticed was when a UXB fell into a 'bomb site' (such as the area shown **Top Left**), the entry hole of the bomb obscured by any debris and rubble present. Note that the entry hole of a 50kg UXB could be as little as 20cm in diameter (**Left**).

J-curve is the term used to describe the characteristic curve commonly followed by an air delivered bomb dropped from height after it penetrates the ground. Typically, as the bomb is slowed by its passage through underlying soils, its trajectory curves towards the surface. Many UXBs are found with their nose cone pointing upwards as a result of this effect. More importantly, however, is the resulting horizontal offset from the point of entry. This is typically a distance of about one third of the bomb's penetration depth, but can be higher in certain conditions (see **Annex F**).

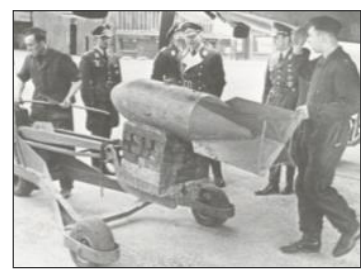
SC250 bomb being loaded onto German bomber

SC 250kg High Explosive Bomb	
Bomb Weight	245-256kg (540-564lb)
Explosive Weight	125-130kg (276-287lb)
Fuze Type	Electrical impact/mechanical time delay fuze
Bomb Dimensions	1640 x 512mm (64.57 x 20.16in)
Body Diameter	368mm (14.5in)
Use	Against railway installations, embankments, flyovers, underpasses, large buildings and below-ground installations.
Remarks	It could be carried by almost all German bomber aircraft and was used to notable effect by the Junkers Ju-87 Stuka (<i>Sturzkampfflugzeug</i> , or dive-bomber).

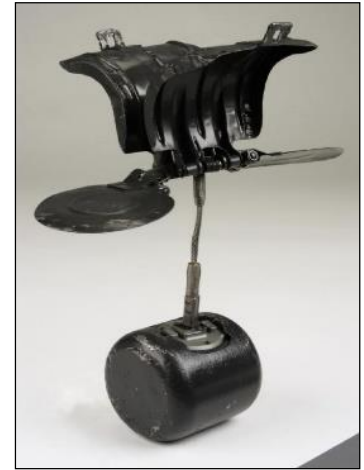
Bomb Weight	Approx. 2kg (4.41lb)
Explosive Weight	Approx. 7.5oz (225 grams) of Amatol surrounded by a layer of bituminous composition.
Fuze Type	41 fuze (time) , 67 fuze (clockwork time delay) or 70 fuze (anti-handling device)
Body Diameter	3in (7.62 cm) diameter, 3.1in (7.874) long
Use	Designed as an anti-personnel/fragmentation weapon. They were delivered by air, being dropped in containers of 23-144 sub-munitions that opened at a predetermined height, thus scattering the bombs.
Remarks	Quite rare. First used against Ipswich in 1940, but were also dropped on Kingston upon Hull, Grimsby and Cleethorpes in June 1943, amongst various other targets in UK. As the bombs fell the outer case flicked open via springs which caused four light metal drogues with a protruding 5 inch steel cable to deploy in the form of a parachute & wind vane, which armed the device as it span.

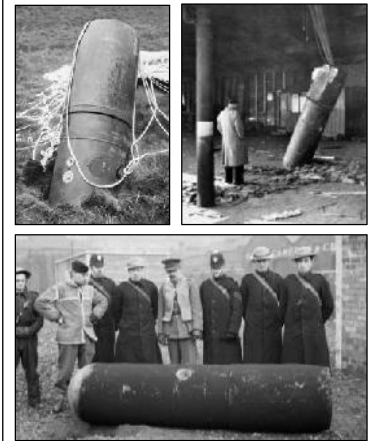
Parachute Mine (Luftmine B / LMB)

Bomb Weight	Approx. 990kg (2176lb)
Explosive Weight	Approx. 705kg (1,554lb)
Fuze Type	Impact/time delay/hydrostatic pressure fuze
Dimensions	2.64m x 0.64m (3.04m with parachute housing)
Use	Against civilian, military and industrial targets. Used as blast bombs and designed to detonate above ground level to maximise damage to a wider area.
Remarks	Deployed a parachute when dropped in order to control its descent. Had the potential to cause extensive damage within a 100m radius.

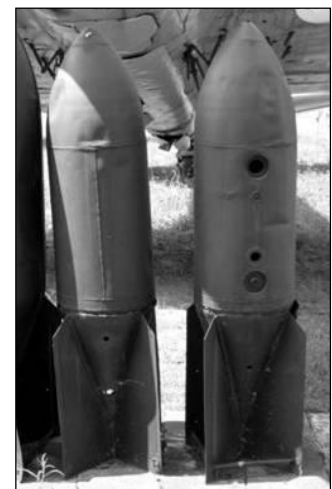
Flam C-250 Oil Bomb	
Bomb Weight	Approx. 125kg (276lb)
Explosive Weight	Approx. 1kg (2.2lb)
Fuze Type	Super-fast electrical impact fuze
Filling	Mixture of 30% petrol and 70% crude oil
Bomb Dimensions	1,650 x 512.2mm (65 x 20.2in)
Body Diameter	368mm (14.5in)
Use	Often used for surprise attacks on ground troops, against troop barracks and industrial installations. Thin casing – not designed for ground penetration.

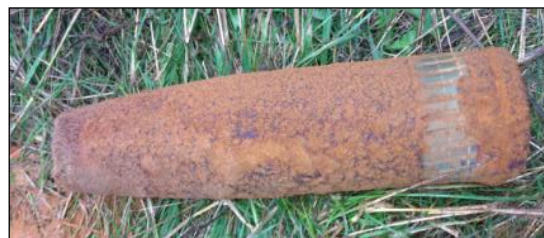
Projectile Weight	28lb (12.6 kg)
Explosive Weight	2.52lbs
Fuze Type	Mechanical Time Fuze
Dimensions	3.7in x 14.7in (94mm x 360mm)
Rate of Fire	10 to 20 rounds per minute
Use	The 3.7in AA Mks 1-3 were the standard Heavy Anti-Aircraft guns of the British Army and were commonly used on the Home Front.
Ceiling	30,000ft to 59,000ft

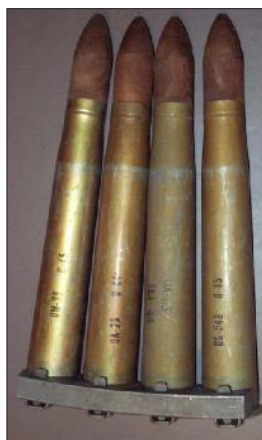
40mm Bofors Projectile

Projectile Weight	1.96lb (0.86kg)
Explosive Weight	300g (0.6lb)
Fuze Type	Impact Fuze
Rate of Fire	120 rounds per minute
Projectile Dimensions	40 x 180mm
Ceiling	23,000ft (7000m)
Remarks	Light quick fire high explosive anti-aircraft projectile. Each projectile fitted with small tracer element. If no target hit, shell would explode when tracer burnt out. Designed to engage aircraft flying below 2,000ft.

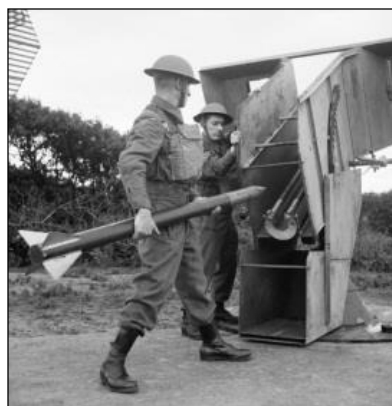
3in Unrotated Projectile (UP) Anti-Aircraft Rocket ("Z" Battery)

HE Projectile Weight	3.4kg (7.6lb)
Explosive Weight	0.96kg (2.13lb)
Filling	High Explosive – TNT. Fitted with aerial burst fuzing
Dimensions of projectile	236 x 83mm (9.29 x 3.25in)
Remarks	As a short range rocket-firing anti-aircraft weapon developed for the Royal Navy. It was used extensively by British ships during the early days of World War II. The UP was also used in ground-based single and 128-round launchers known as Z Batteries. Shell consists of a steel cylinder reduced in diameter at the base and threaded externally to screw into the shell ring of the rocket motor.
